**Total Land Subsidence in the Bowie and San Simon Areas, Cochise County**  
**Based on Radarsat-2 Satellite Interferometric Synthetic Aperture Radar (InSAR) Data**  
**Time Period of Analysis: 1.0 Years 04/20/2022 To 05/09/2023**

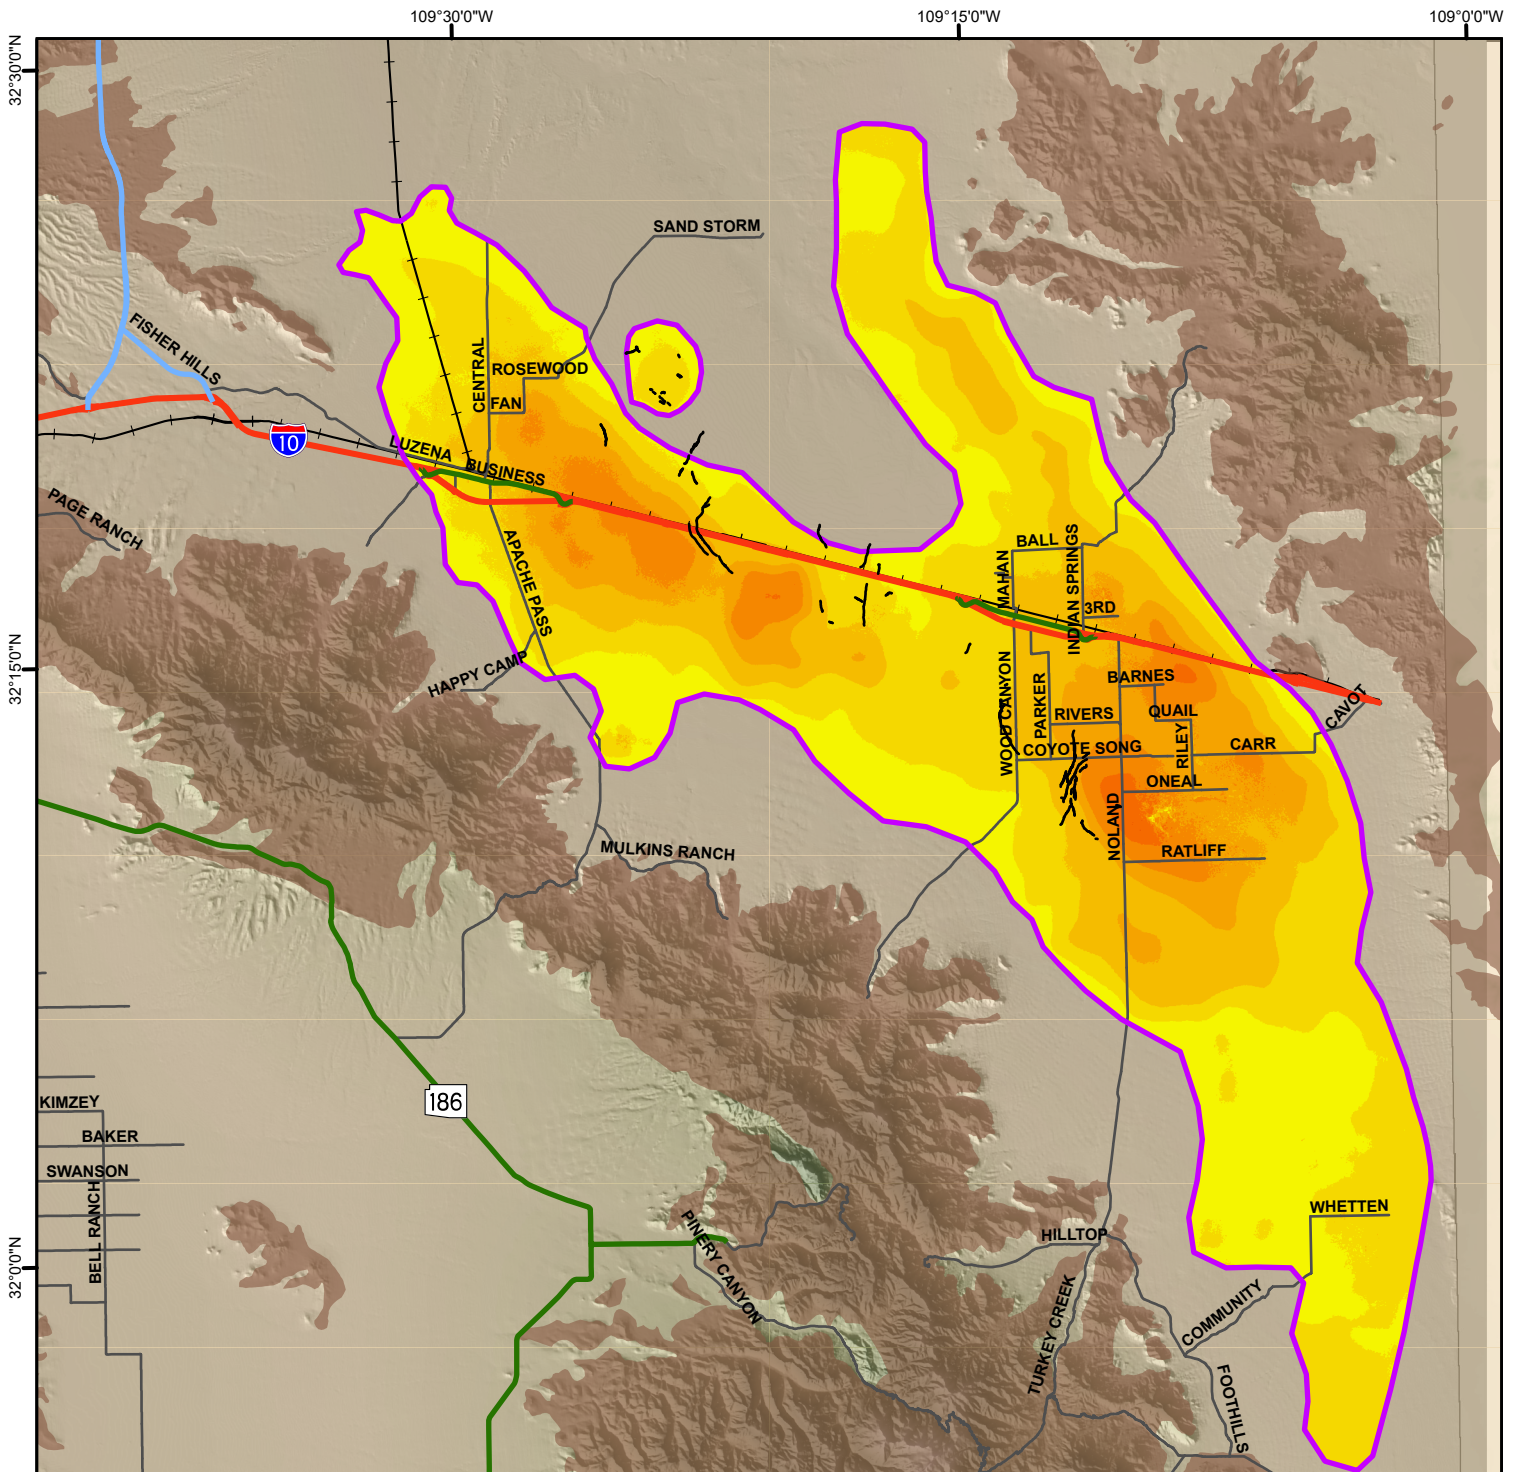
Decorrelation (white areas) are areas where the phase of the received satellite signal changed between satellite passes, causing the data to be unusable. This occurs in areas where the land surface has been disturbed (i.e. bodies of water, snow, agriculture areas, areas of development, etc).

Earth fissures were mapped by the Arizona Geological Survey. For information on earth fissures visit: [www.azgs.gov/EFC](http://www.azgs.gov/EFC)
